# Geotechnical Evaluation

Sycamore Canyon School

Building Additions

May 30, 2019 | Project No. 108773001

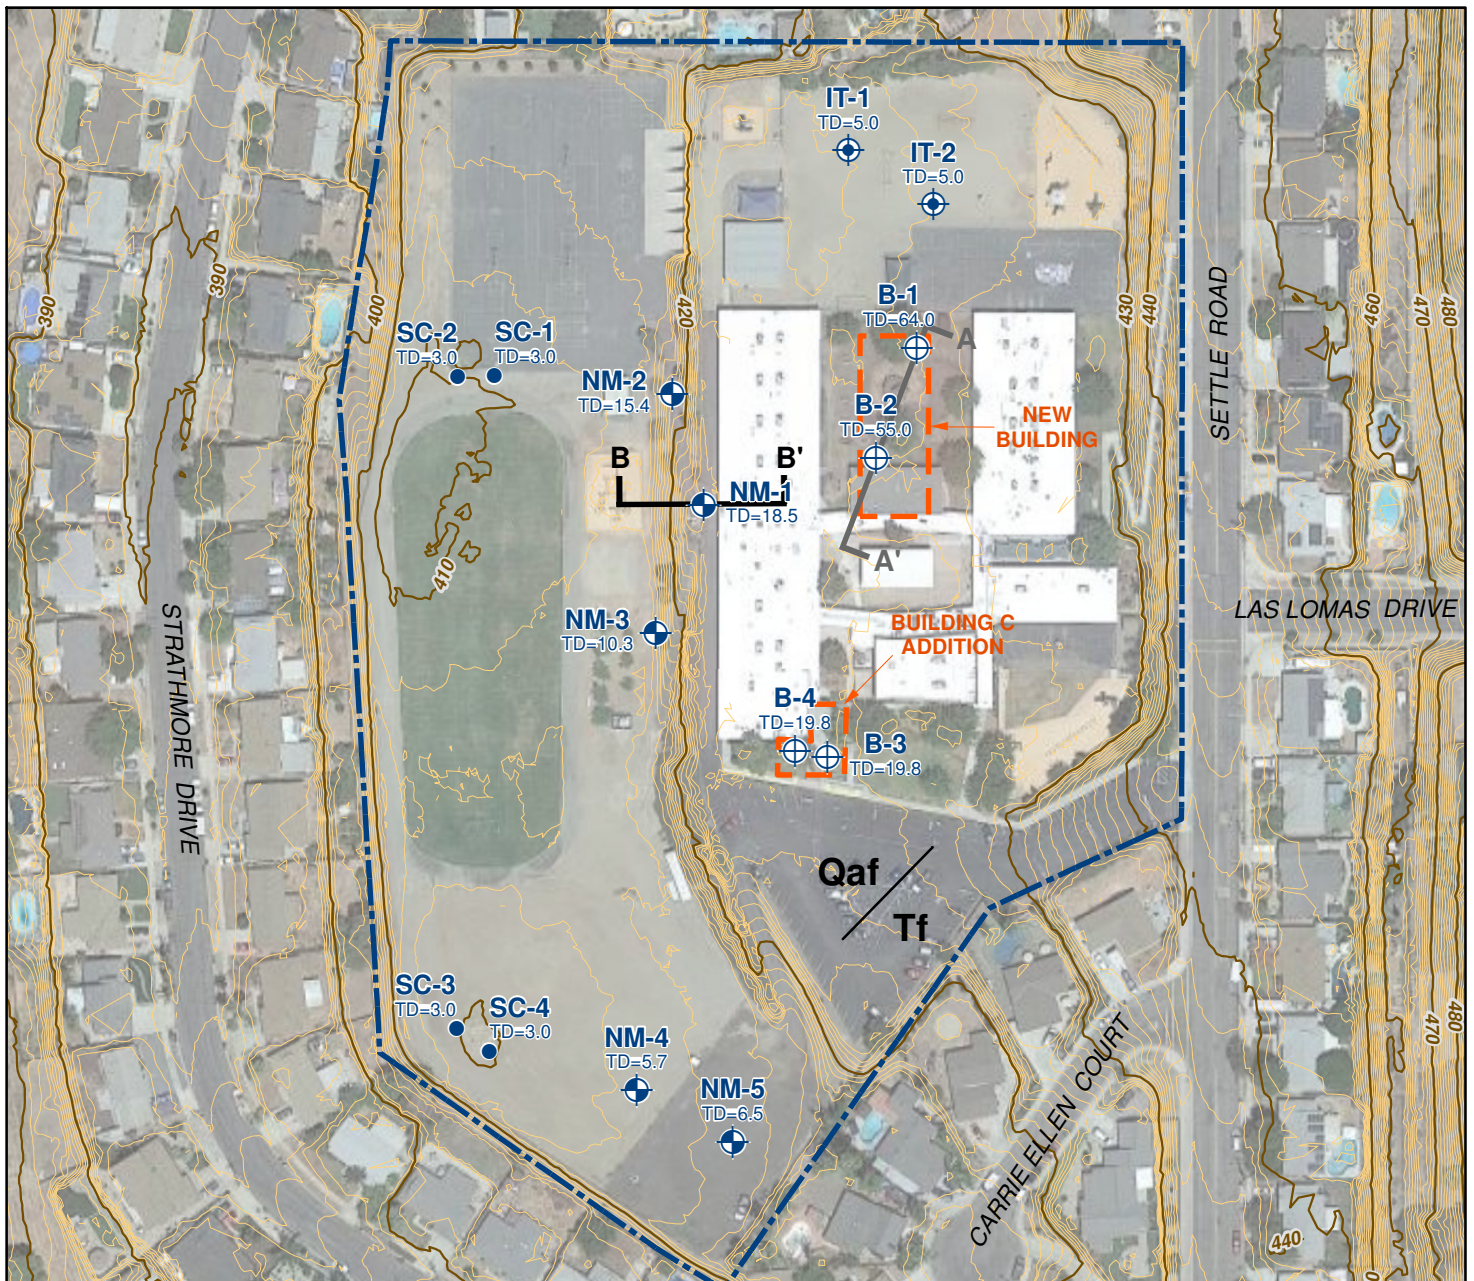
**BORING LOCATIONS**

LEGEND	
<b>NM-5</b> TD=6.5 	BORING TD=TOTAL DEPTH IN FEET
<b>B-4</b> TD=15.4 	PREVIOUS BORING, (NINYO & MOORE, 2007) TD=TOTAL DEPTH IN FEET
<b>IT-2</b> TD=5.0 	INFILTRATION TEST TD=TOTAL DEPTH IN FEET
<b>SC-4</b> TD=3.0 	PREVIOUS INFILTRATION TEST, (NINYO & MOORE, 2017) TD=TOTAL DEPTH IN FEET
	PROPOSED BUILDING ADDITION
	SITE BOUNDARY
	CROSS SECTION
	CROSS SECTION (NINYO & MOORE, 2007)
	INDEX/INTERMEDIATE TOPOGRAPHIC CONTOUR
<b>Qaf</b>	FILL
<b>Tf</b>	FRIARS FORMATION

As a means of evaluating the infiltration characteristics of near-surface materials, infiltration tests were performed on April 22 and 23, 2019 at two locations designated IT-1 and IT-2 (Figure 2). Additionally, infiltration tests were performed at four locations designated SC-1 through SC-4 (Figure 2) on April 13 and 14, 2017 as part of a previous evaluation (Ninyo & Moore 2017). Borings IT-1 and IT-2 were manually excavated to depths up to approximately 5 feet using a 6-inch diameter hand auger. Borings SC-1 through SC-4 were manually excavated to depths up to approximately 3 feet using a 6-inch diameter hand auger. Following the excavation, both infiltration test locations were prepared by placing approximately 2 inches of gravel on the bottom, installing a 2-inch

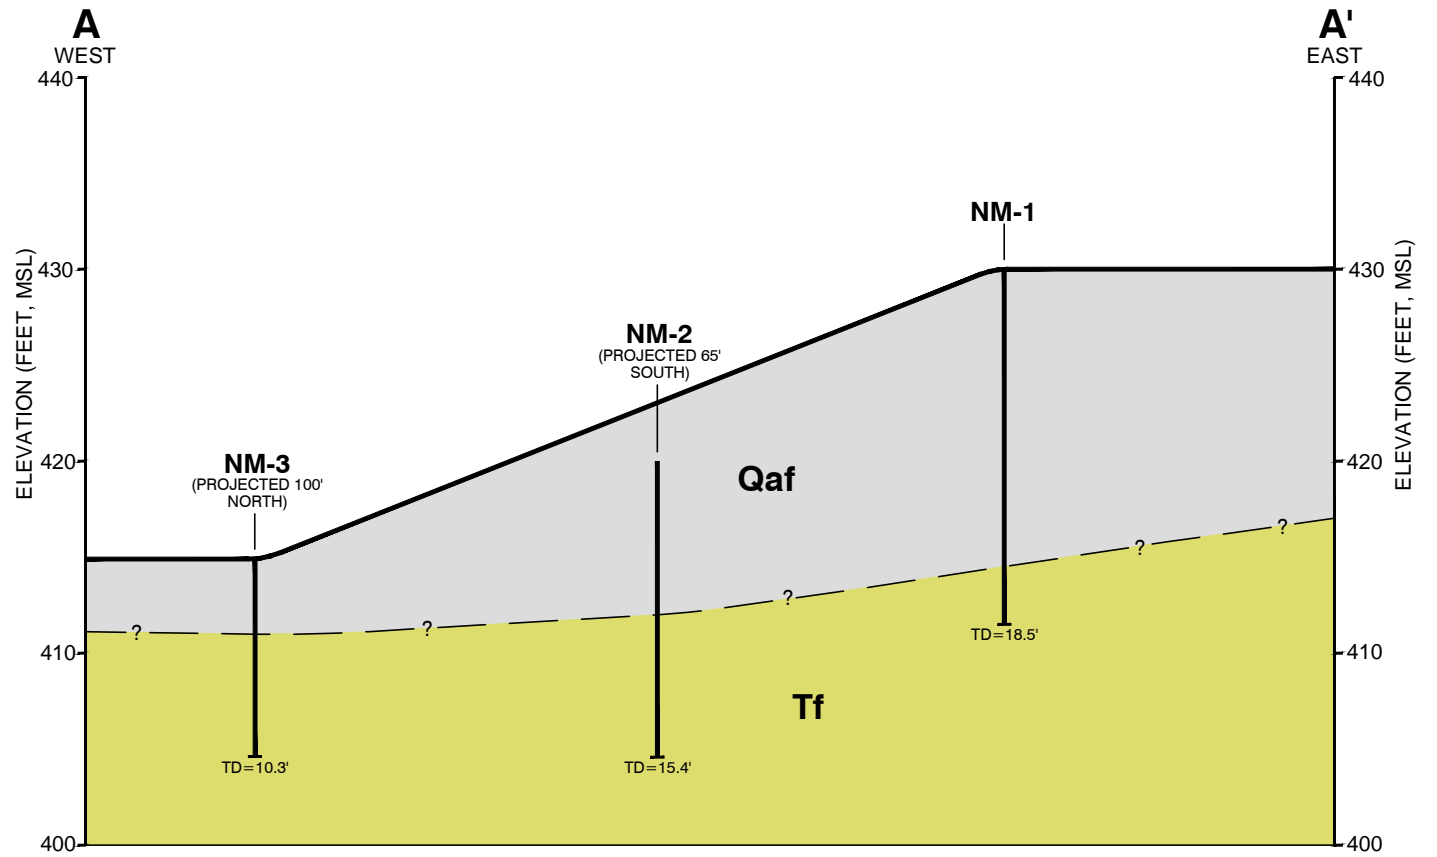
FIGURE 4A

**NM-3** BORING  
 TD=TOTAL DEPTH IN FEET  
 TD=10.3'

Geologic units mapped at the site and encountered during our subsurface exploration include fill, Quaternary-age younger and older alluvial deposits, landslide deposits, and materials of the Tertiary-age Friars Formation (Kennedy and Tan, 2008). Generalized descriptions of the earth units encountered during our field reconnaissance and subsurface exploration are provided in the subsequent sections. Additional descriptions of the subsurface units are provided on the logs of the borings in Appendix A. The geology of the site is shown on Figure 3 and geologic cross sections are shown on Figures 4A and 4B.

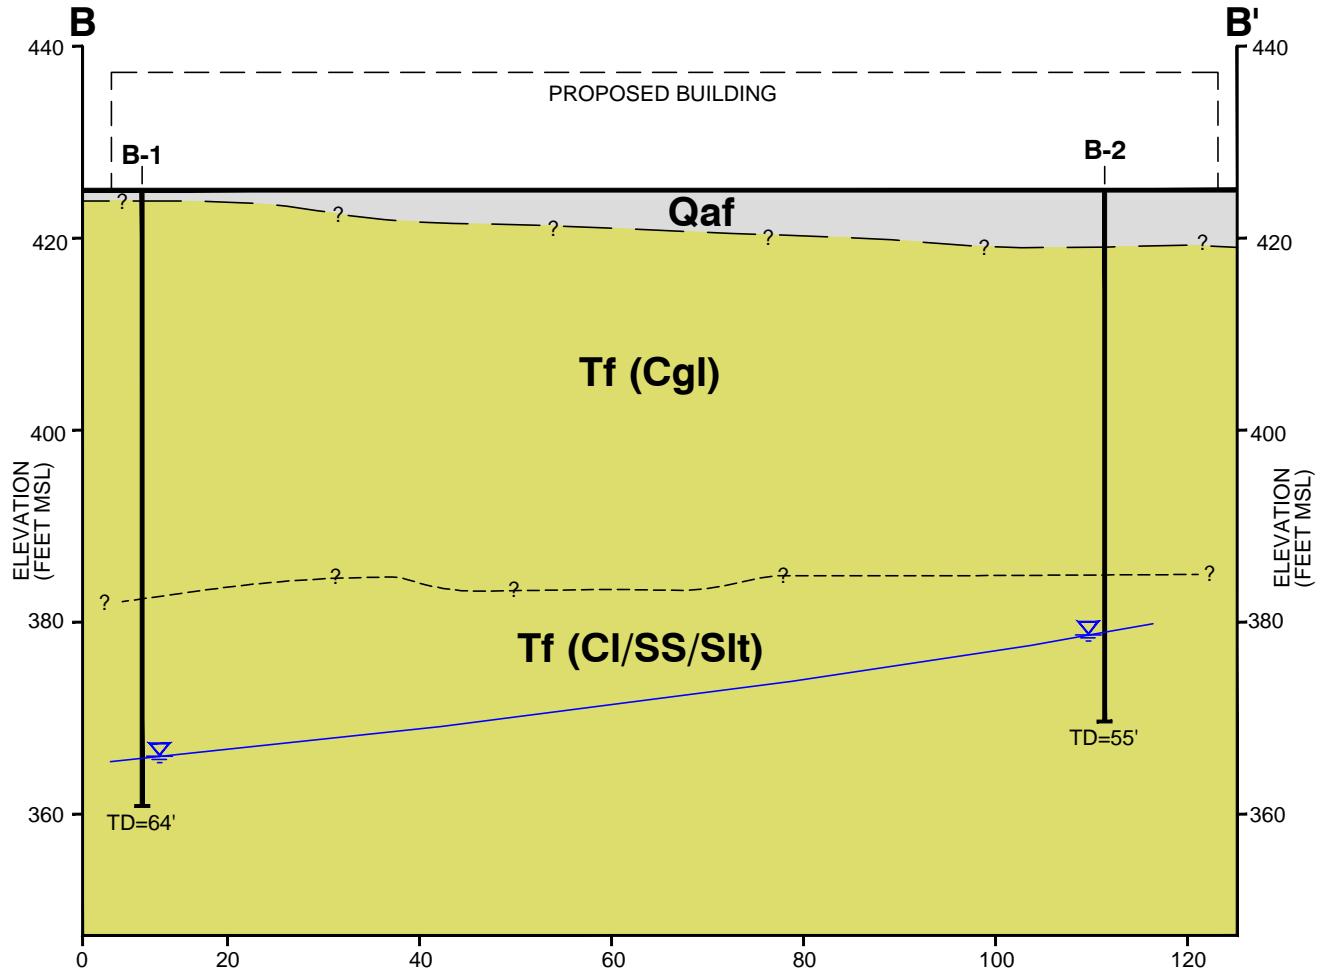
FIGURE 4B

LEGEND	
<b>B-2</b> ↓ TD=55'	PREVIOUS BORING (NINYO & MOORE, 2007) TD=TOTAL DEPTH IN FEET
<b>Qaf</b>	FILL
<b>Tf (Cgl)</b>	FRIARS FORMATION - INTERBEDDED CONGLOMERATE, CLAYSTONE & SANDSTONE
<b>Tf (Cl/SS/Slt)</b>	FRIARS FORMATION - INTERBEDDED CLAYSTONE, SANDSTONE, AND SILTSTONE
— ? —	APPROXIMATE LOCATION OF GEOLOGIC CONTACT QUERIED WERE QUESTIONABLE
- - - ? - - -	APPROXIMATE LOCATION OF VARIATION IN LITHOLOGY WITHIN GEOLOGIC UNIT
— ▽ —	APPROXIMATE LOCATION OF GROUNDWATER ELEVATION

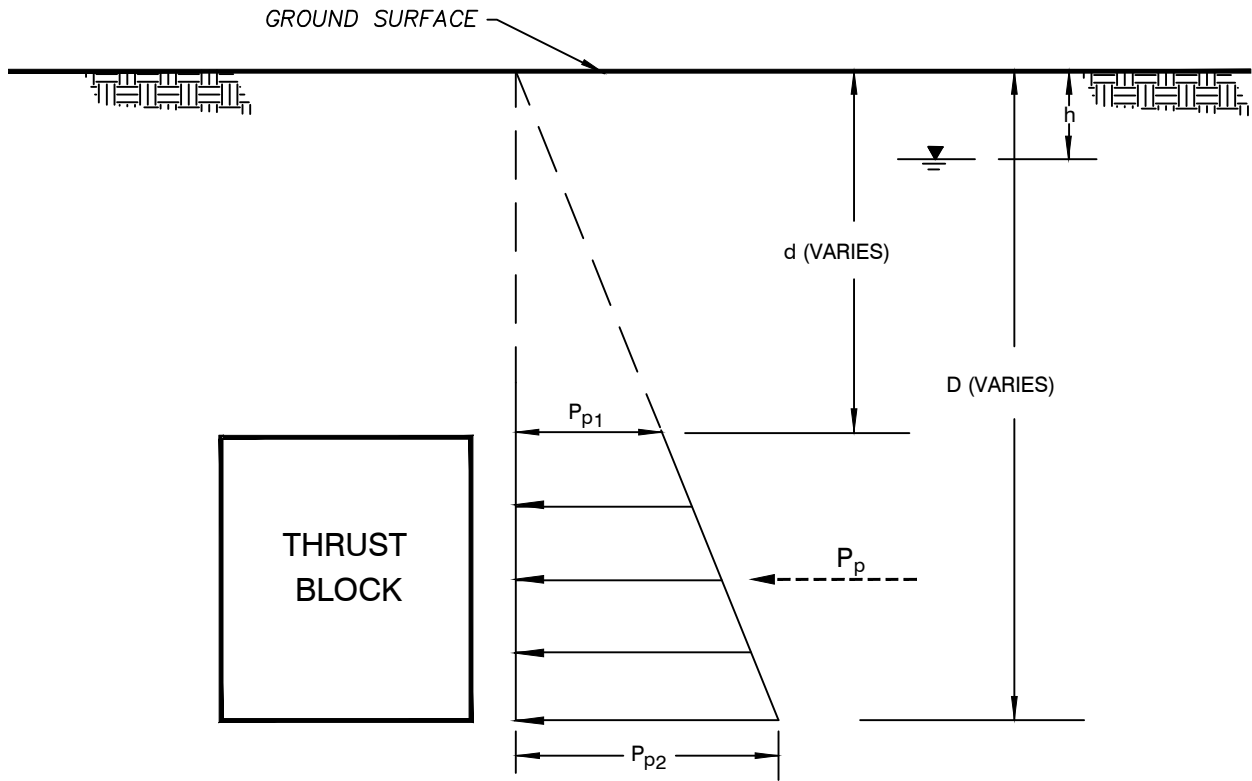
THRUST BLOCK LATERAL EARTH PRESSURE DIAGRAM

1. GROUNDWATER BELOW BLOCK

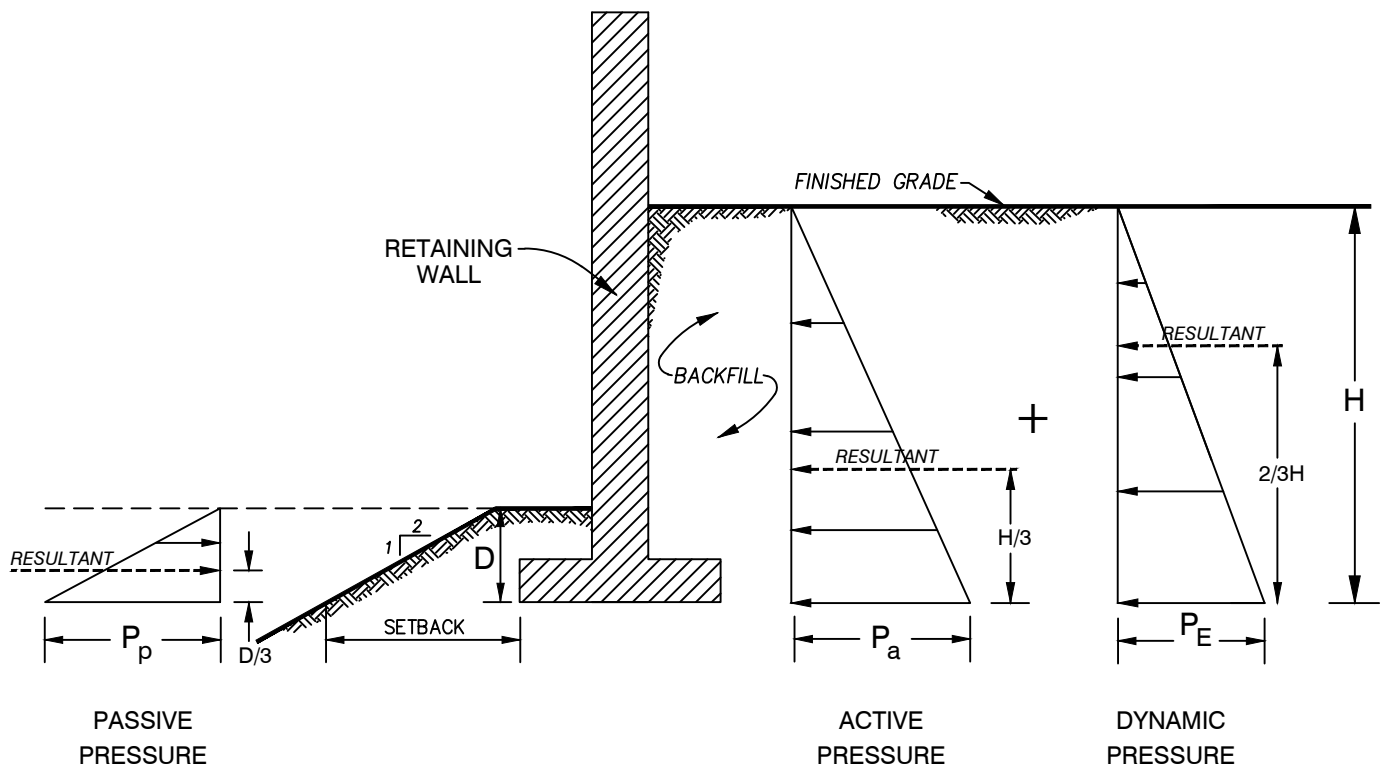
1. ASSUMES NO HYDROSTATIC PRESSURE BUILD-UP BEHIND THE RETAINING WALL
2. GRANULAR BACKFILL MATERIALS SHOULD BE USED FOR RETAINING WALL BACKFILL
3. DRAINS AS RECOMMENDED IN THE RETAINING WALL DRAINAGE DETAIL SHOULD BE INSTALLED BEHIND THE RETAINING WALL
4. DYNAMIC LATERAL EARTH PRESSURE IS BASED ON A PEAK GROUND ACCELERATION OF 0.39g
5.  $P_E$  IS CALCULATED IN ACCORDANCE WITH THE RECOMMENDATIONS OF MONONOBE AND MATSUO (1929), AND ATIK AND SITAR (2010)
6. SURCHARGE PRESSURES CAUSED BY VEHICLES OR NEARBY STRUCTURES ARE NOT INCLUDED
7.  $H$  AND  $D$  ARE IN FEET
8. SETBACK SHOULD BE IN ACCORDANCE WITH THE CBC

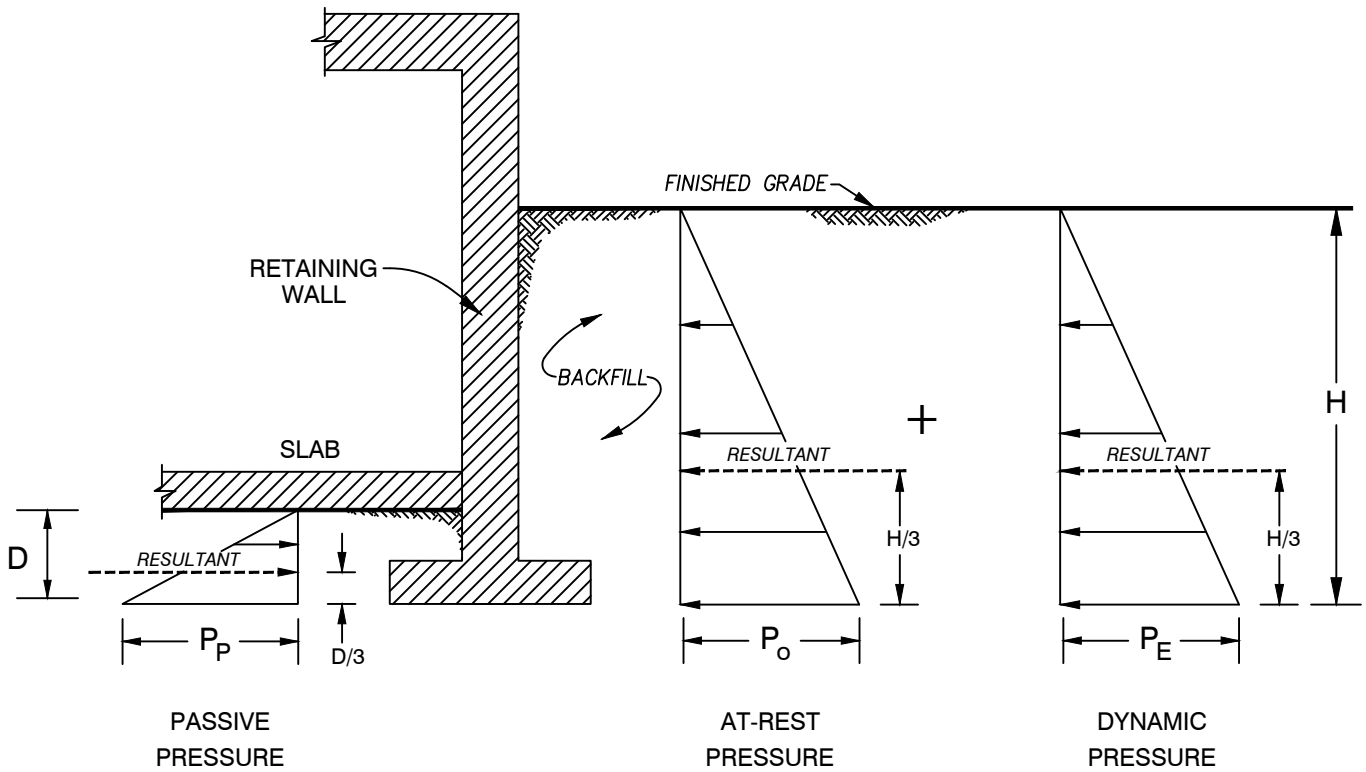
1. ASSUMES NO HYDROSTATIC PRESSURE BUILD-UP BEHIND THE RETAINING WALL
2. GRANULAR LOW EXPANSIVE BACKFILL MATERIALS SHOULD BE USED FOR RETAINING WALL BACKFILL
3. DRAINS AS RECOMMENDED IN THE RETAINING WALL DRAINAGE DETAIL SHOULD BE INSTALLED BEHIND THE RETAINING WALL
4. DYNAMIC LATERAL EARTH PRESSURE IS BASED ON A PEAK GROUND ACCELERATION OF 0.39g
5.  $P_e$  IS CALCULATED IN ACCORDANCE WITH THE RECOMMENDATIONS OF MONONOBE AND MATSUO (1929), AND ATIK AND SITAR (2010)
6. SURCHARGE PRESSURES CAUSED BY VEHICLES OR NEARBY STRUCTURES ARE NOT INCLUDED
7. H AND D ARE IN FEET

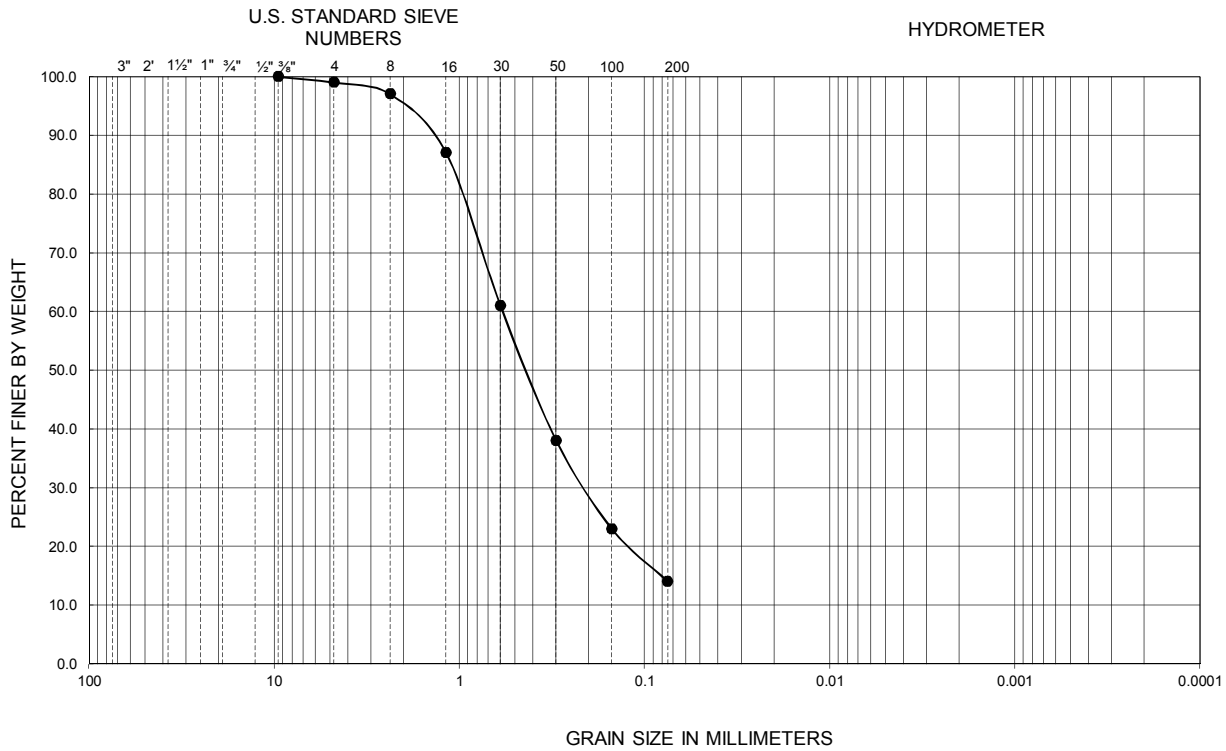
FIGURE B-1

Symbol	Sample Location	Depth (ft)	Liquid Limit	Plastic Limit	Plasticity Index	D <sub>10</sub>	D <sub>30</sub>	D <sub>60</sub>	C <sub>u</sub>	C <sub>c</sub>	Passing No. 200 (percent)	USCS
●	NM-1	10.0-11.5	--	--	--	--	--	--	--	--	14	SM

PERFORMED IN GENERAL ACCORDANCE WITH ASTM D 422

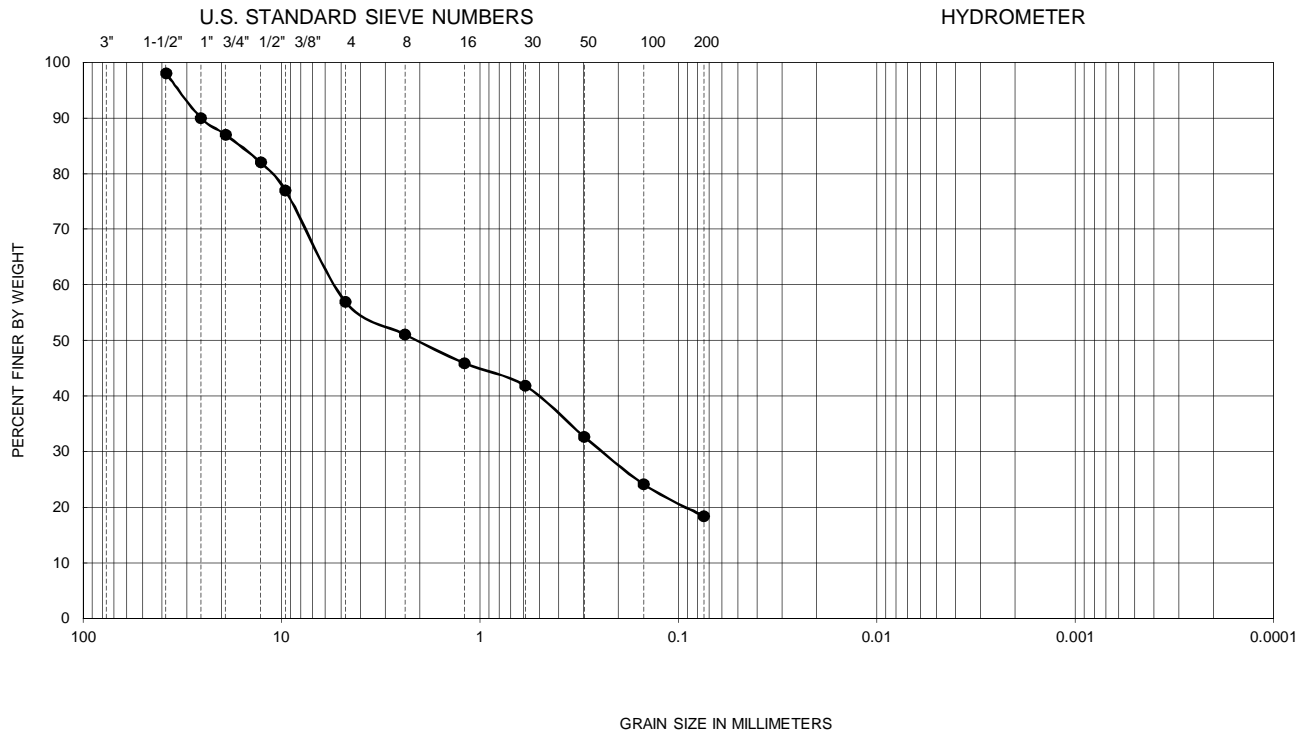
Symbol	Sample Location	Depth (ft)	Liquid Limit	Plastic Limit	Plasticity Index	D <sub>10</sub>	D <sub>30</sub>	D <sub>60</sub>	C <sub>u</sub>	C <sub>c</sub>	Passing No. 200 (percent)	USCS
●	NM-2	0.6-5.0	--	--	--	--	--	--	--	--	18	SC

PERFORMED IN GENERAL ACCORDANCE WITH ASTM D 422

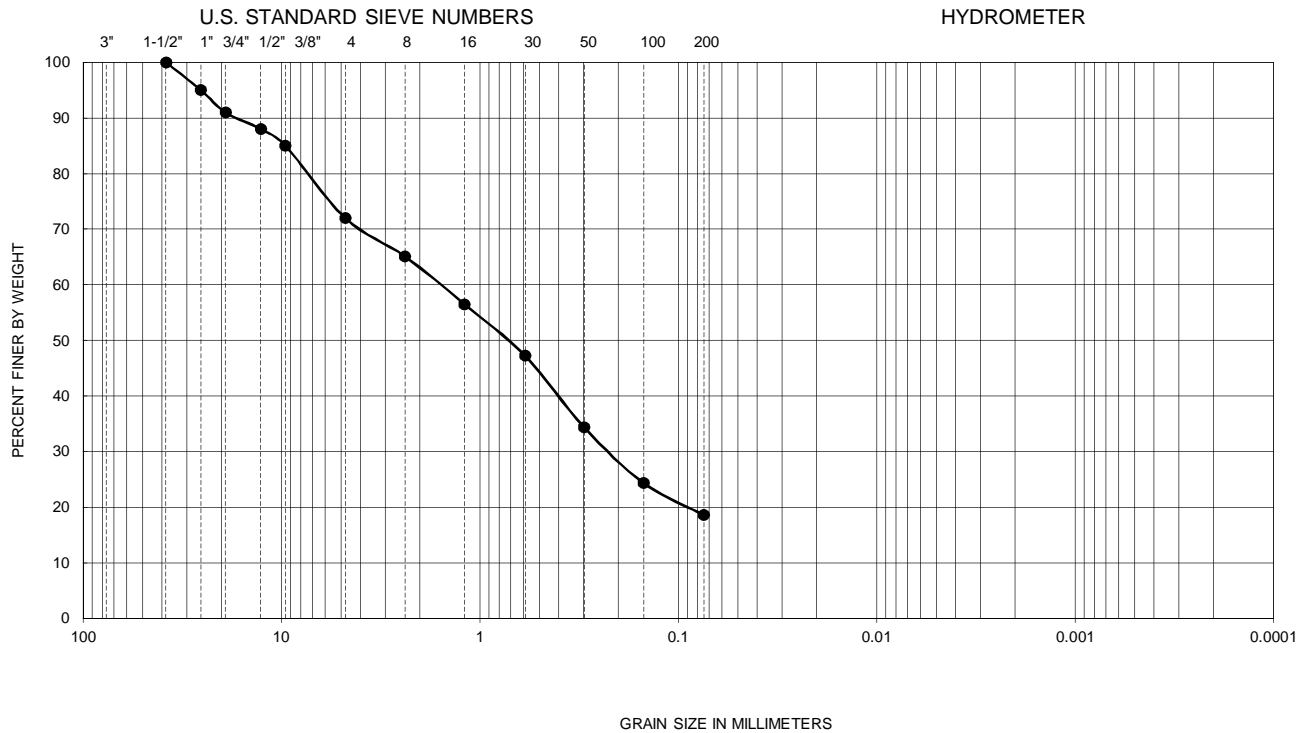
Symbol	Sample Location	Depth (ft)	Liquid Limit	Plastic Limit	Plasticity Index	D <sub>10</sub>	D <sub>30</sub>	D <sub>60</sub>	C <sub>u</sub>	C <sub>c</sub>	Passing No. 200 (percent)	USCS
●	NM-3	0.0-5.0	--	--	--	--	--	--	--	--	19	SC

PERFORMED IN GENERAL ACCORDANCE WITH ASTM D 422

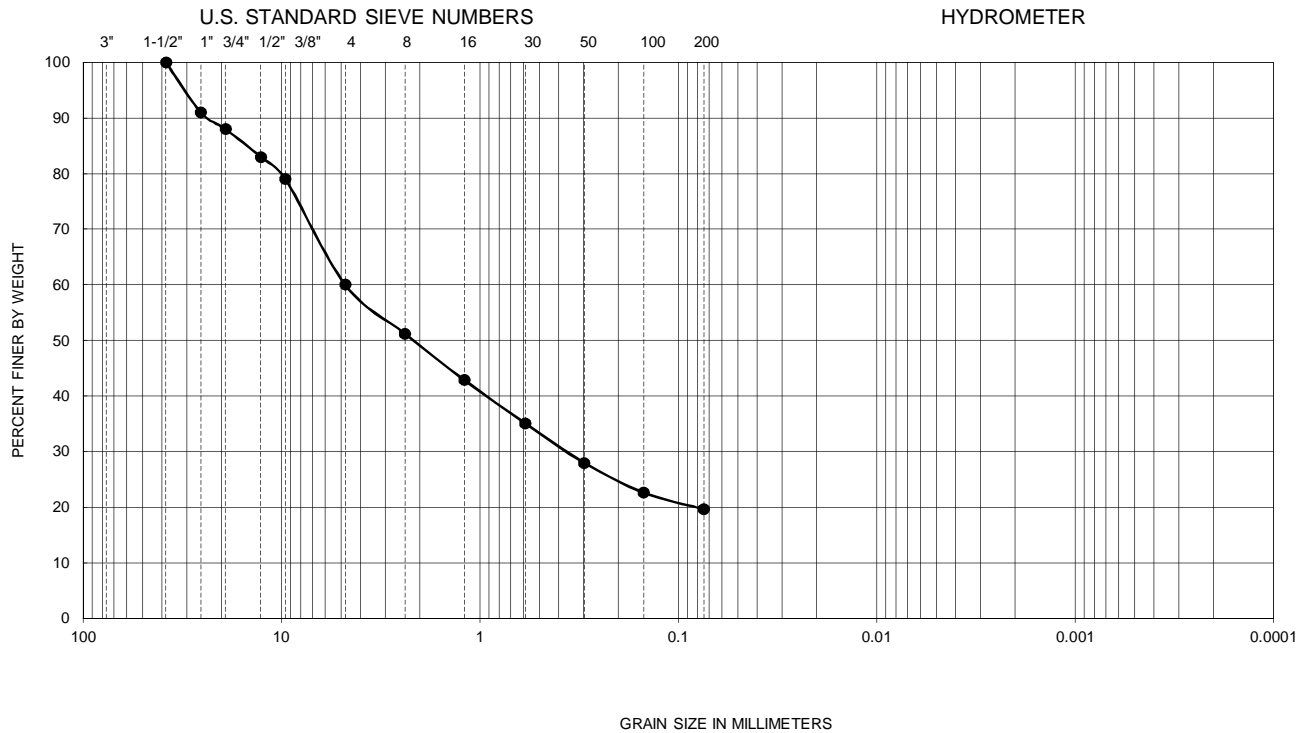
Symbol	Sample Location	Depth (ft)	Liquid Limit	Plastic Limit	Plasticity Index	D <sub>10</sub>	D <sub>30</sub>	D <sub>60</sub>	C <sub>u</sub>	C <sub>c</sub>	Passing No. 200 (percent)	USCS
●	NM-5	0.0-5.0	--	--	--	--	--	--	--	--	20	SC

PERFORMED IN GENERAL ACCORDANCE WITH ASTM D 422

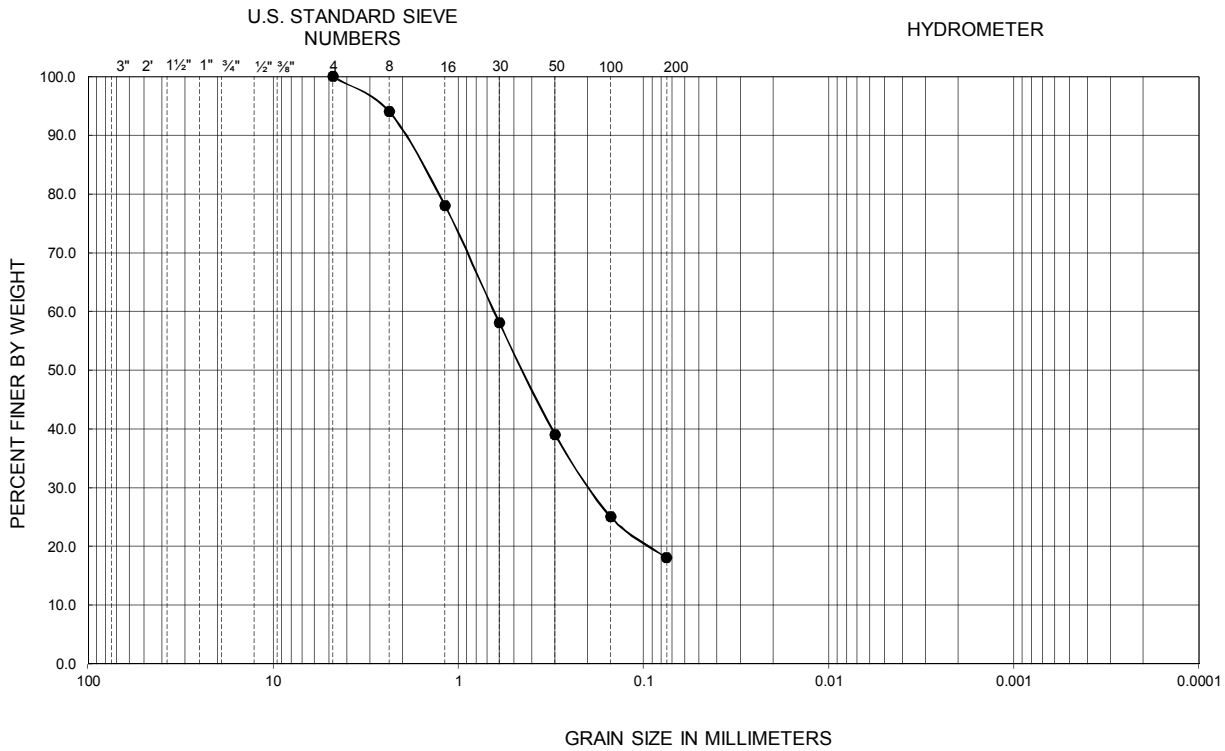
FIGURE B-5

Symbol	Sample Location	Depth (ft)	Liquid Limit	Plastic Limit	Plasticity Index	D <sub>10</sub>	D <sub>30</sub>	D <sub>60</sub>	C <sub>u</sub>	C <sub>c</sub>	Passing No. 200 (percent)	USCS
●	IT-1	0.5-5.0	--	--	--	--	--	--	--	--	18	SC

PERFORMED IN GENERAL ACCORDANCE WITH ASTM D 422

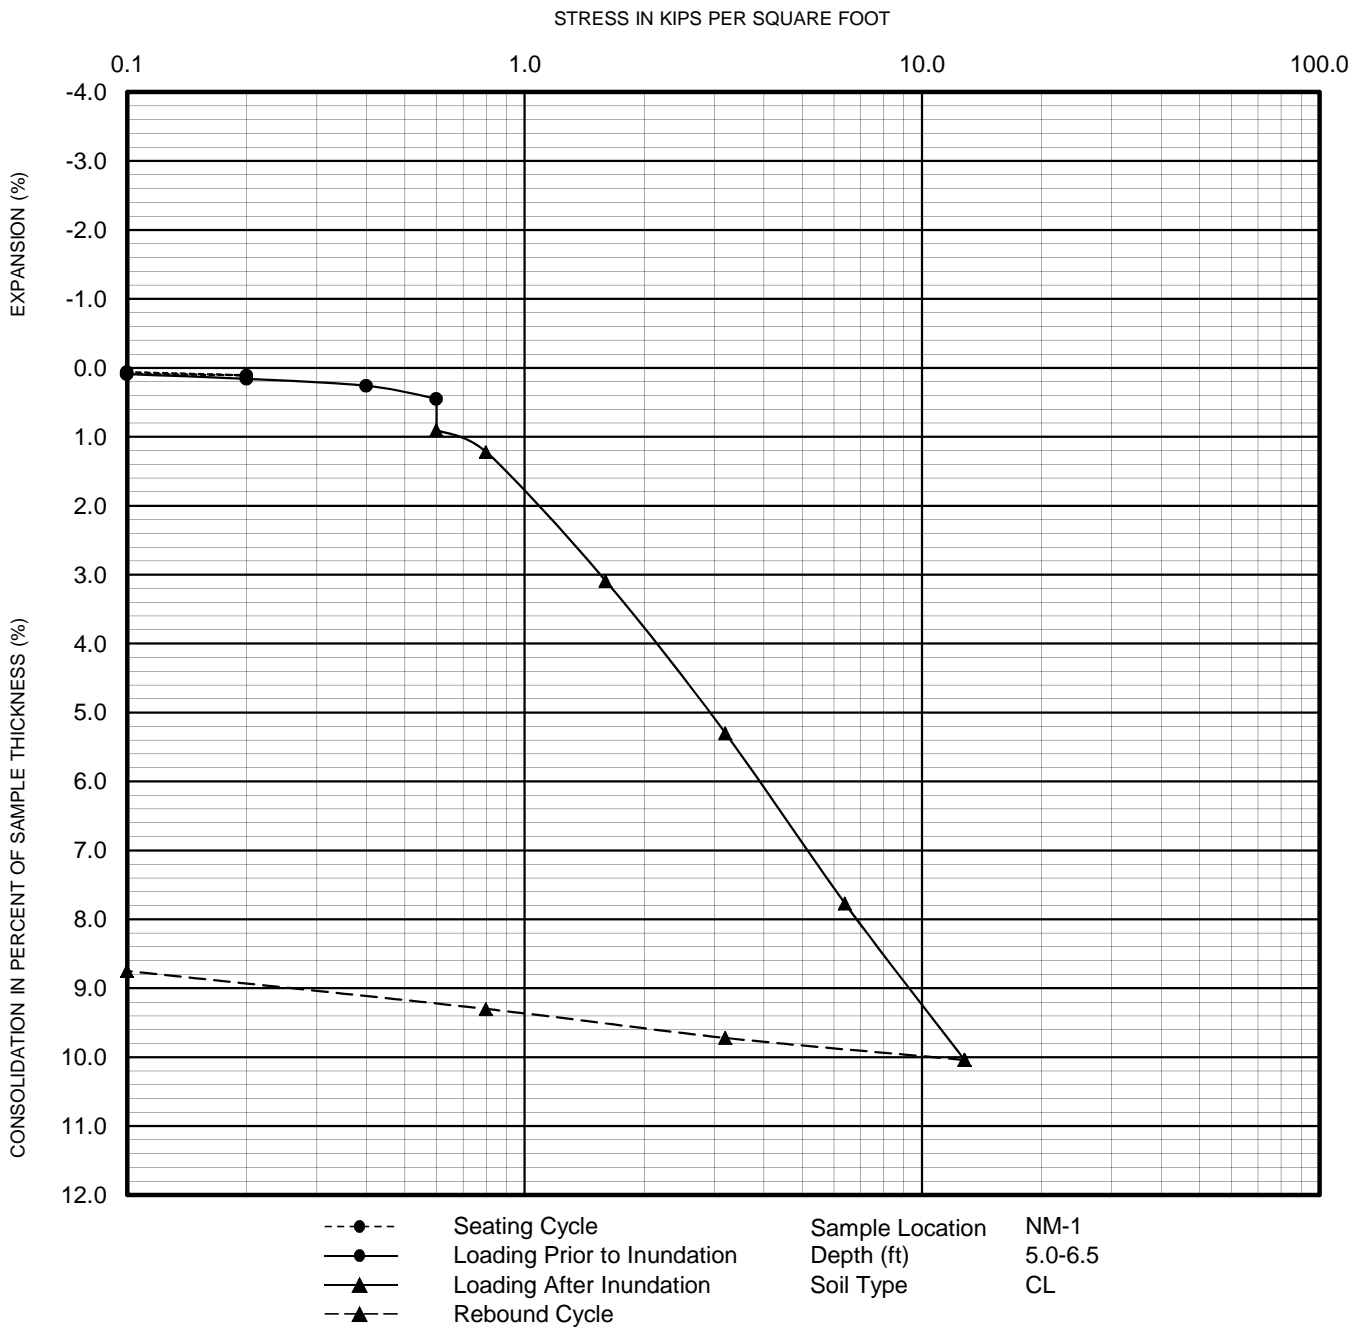
PERFORMED IN GENERAL ACCORDANCE WITH ASTM D 2435

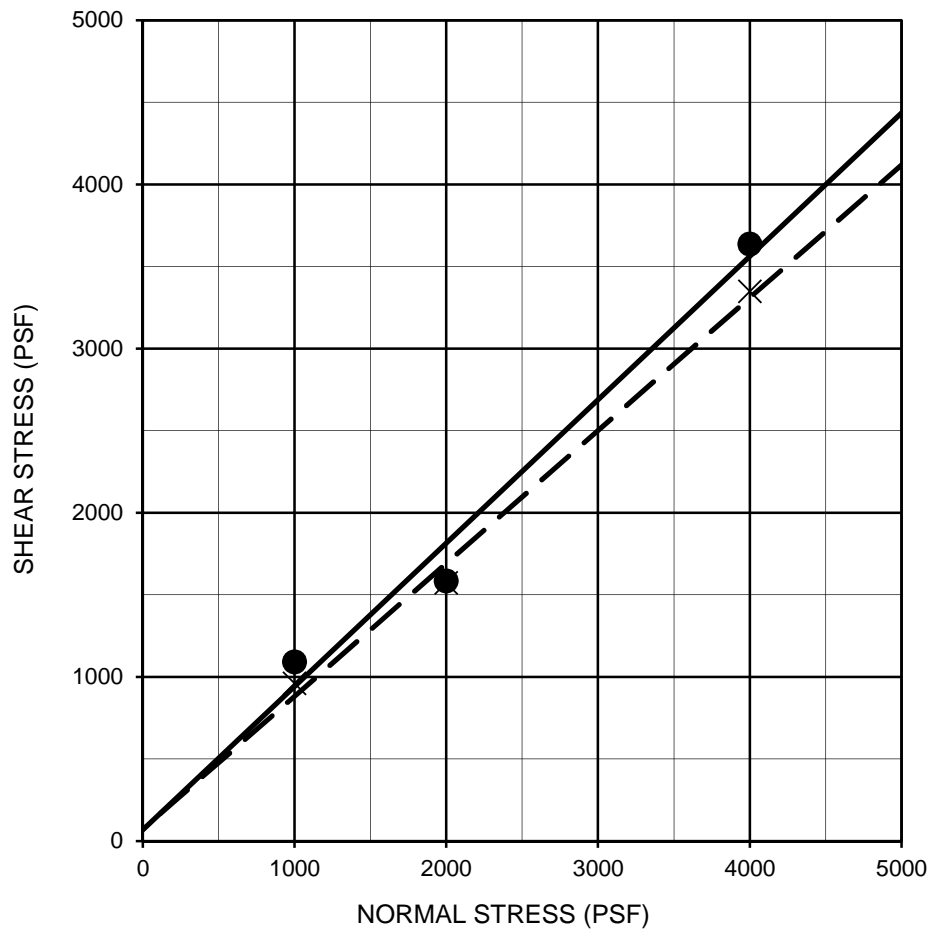
Description	Symbol	Sample Location	Depth (ft)	Shear Strength	Cohesion (psf)	Friction Angle (degrees)	Soil Type
Clayey SANDSTONE	●	NM-2	10.0-10.3	Peak	70	41	Formation
Clayey SANDSTONE	- - X - -	NM-2	10.0-10.3	Ultimate	70	39	Formation

PERFORMED IN GENERAL ACCORDANCE WITH ASTM D 3080

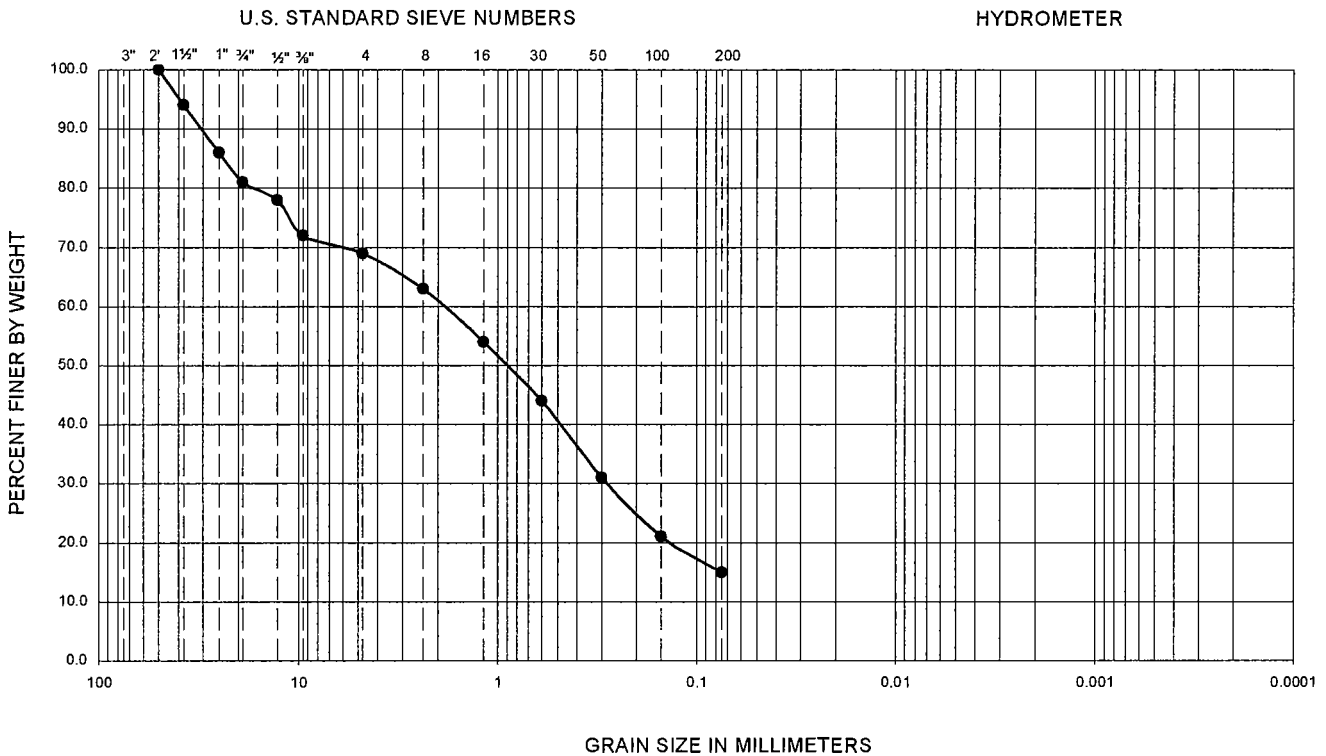
Symbol	Sample Location	Depth (ft)	Liquid Limit	Plastic Limit	Plasticity Index	D <sub>10</sub>	D <sub>30</sub>	D <sub>60</sub>	C <sub>u</sub>	C <sub>c</sub>	Passing No. 200 (%)	USCS
●	B-1	0.0-5.0	--	--	--	--	--	--	--	--	15	SM

PERFORMED IN GENERAL ACCORDANCE WITH ASTM D 422-63 (02)

<b>Ninyo &amp; Moore</b>		<b>GRADATION TEST RESULTS</b>		<b>FIGURE</b> <b>B-1</b>
PROJECT NO.	DATE	SYCAMORE CANYON SCHOOL SANTEE, CALIFORNIA		
106111001	8/07

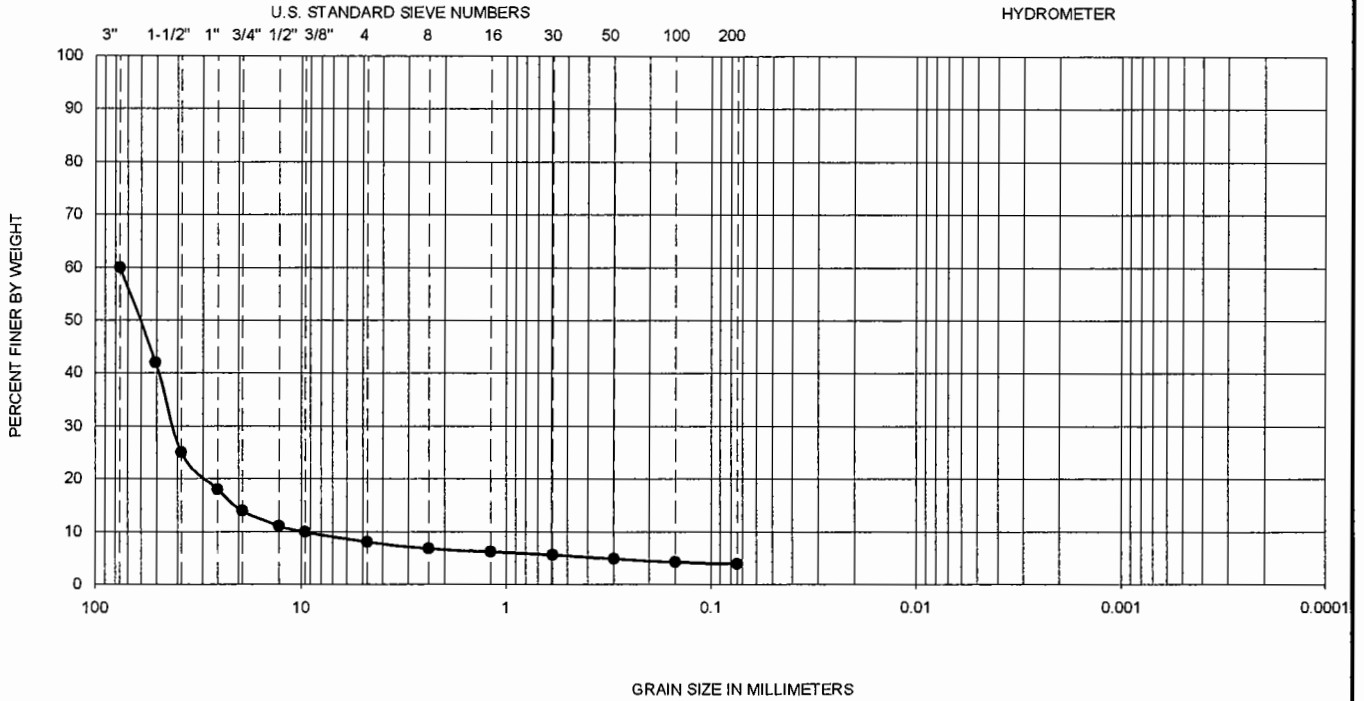
Symbol	Hole No.	Depth (ft)	Liquid Limit	Plastic Limit	Plasticity Index	D <sub>10</sub>	D <sub>30</sub>	D <sub>60</sub>	C <sub>u</sub>	C <sub>c</sub>	Passing No. 200 (%)	U.S.C.S
●	B-3	0.5-5.0	--	--	--	--	--	--	--	--	4	GC

PERFORMED IN GENERAL ACCORDANCE WITH ASTM D 422-63 (02)

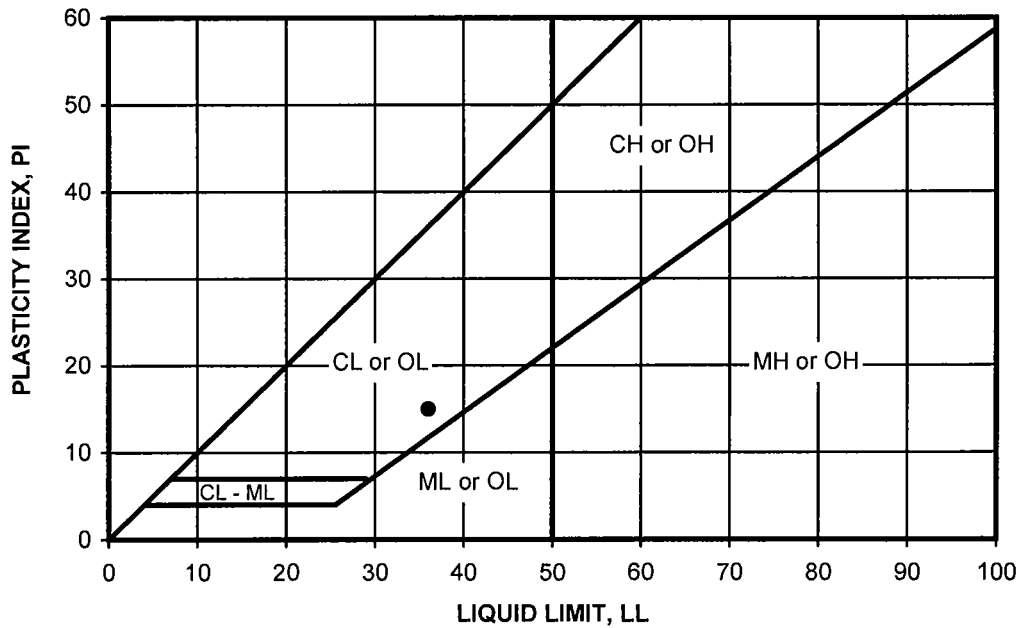
SYMBOL	LOCATION	DEPTH (FT)	LIQUID LIMIT, LL	PLASTIC LIMIT, PL	PLASTICITY INDEX, PI	USCS CLASSIFICATION (Fraction Finer Than No. 40 Sieve)	USCS (Entire Sample)
•	B-2	15.0-16.5	36	21	15	CL	CL

PERFORMED IN GENERAL ACCORDANCE WITH ASTM D 4318-05

<b>Ninyo &amp; Moore</b>		<b>ATTERBERG LIMITS TEST RESULTS</b>	FIGURE
PROJECT NO.	DATE	SYCAMORE CANYON SCHOOL SANTEE, CALIFORNIA	<b>B-3</b>
106111001	8/07
